SYSTEM BRIEF DETAIL

Report detailing the classification of a Hilti ventilated façade with thermal bridge reducing bracket and mineral wool insulation tested in accordance with the requirement as described in British Standard 8414

CUSTOMER CLASSIFICATION REPORT

Report number: 101512.002

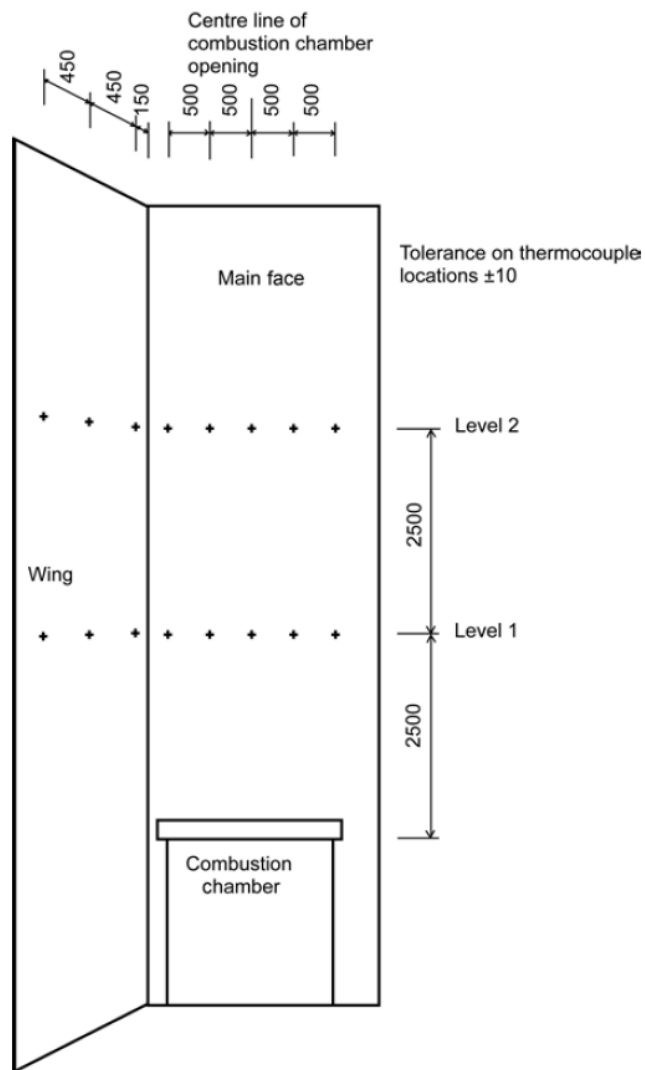
Figure 1. Location of thermocouples – dimensions in mm

Figure 1 shows the location of thermocouples used in the test.

Fire spread is measured by type K thermocouples set at levels 1 and 2 (Figure 1). The start time for fire spread is initiated when the temperature first recorded by any external thermocouple at level 1 equals or exceeds a 200 °C temperature rise above the start temperature and remains above this value for at least 30 s.

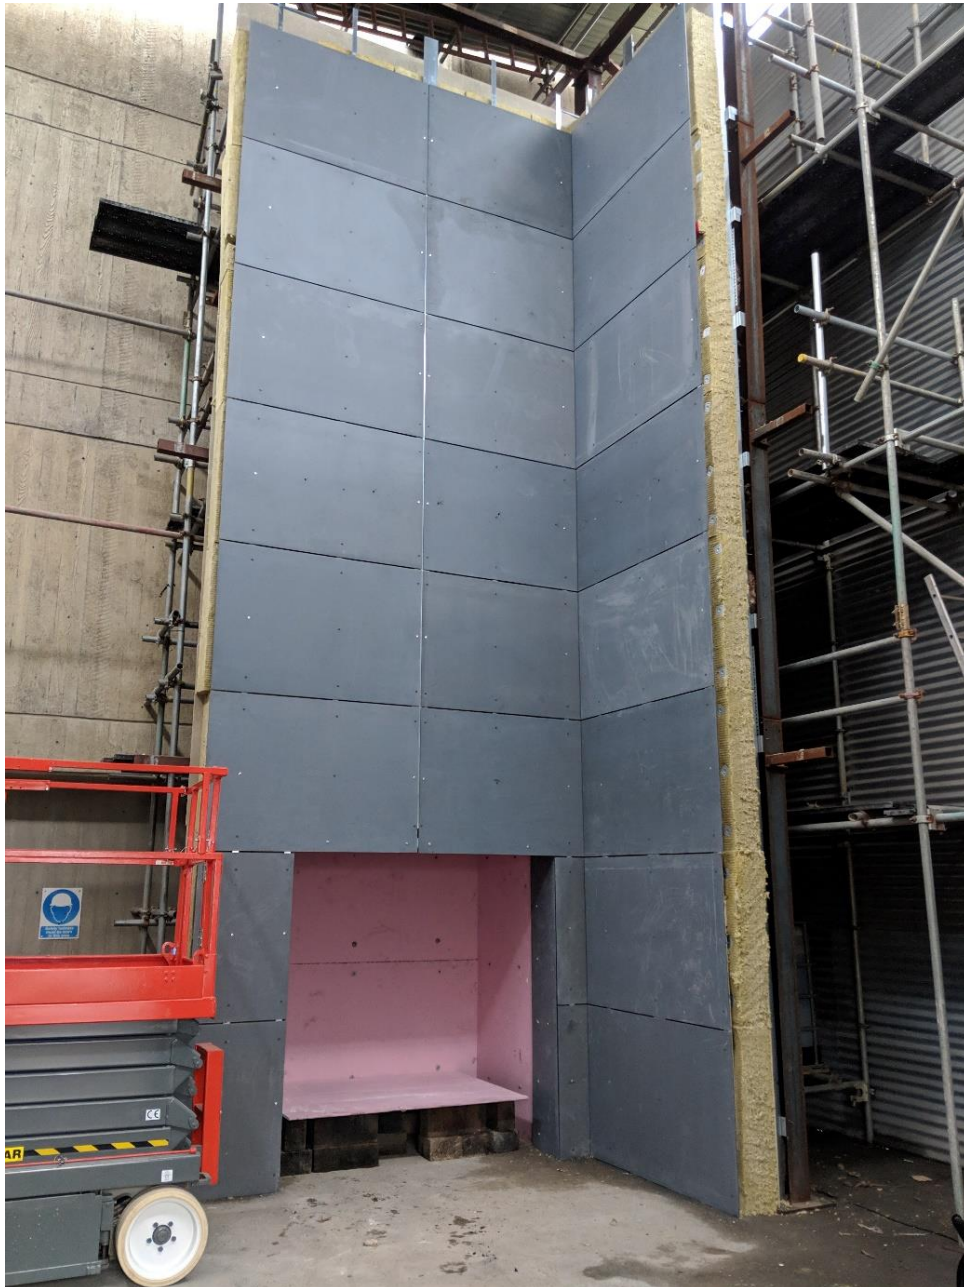
Figure 1 – Cladding system installation, pre-test.

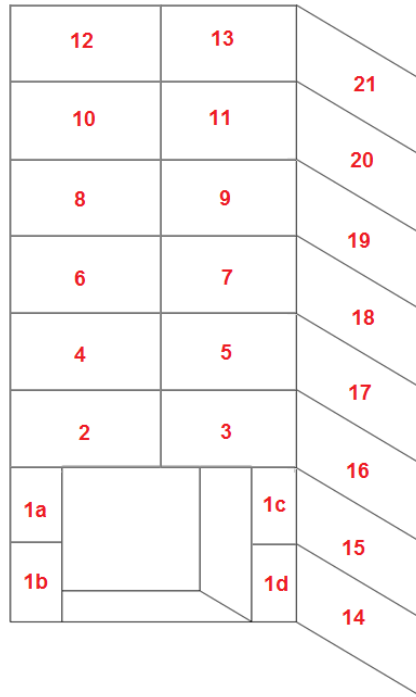
For identification purposes during the test, the rain screen panels on the front face around the burn box were numbered 1a-d, above the burn box on the front face numbered 2-13 and, on the wing, numbered 14-21.

Figure 2 – Numbering system for rain screen panels
